ENERGY ASSESSMENT AUDIT REPORT

WAR MEMORIAL COMPLEX

700 HALIA NAKOA STREET

WAILUKU, HI 96793

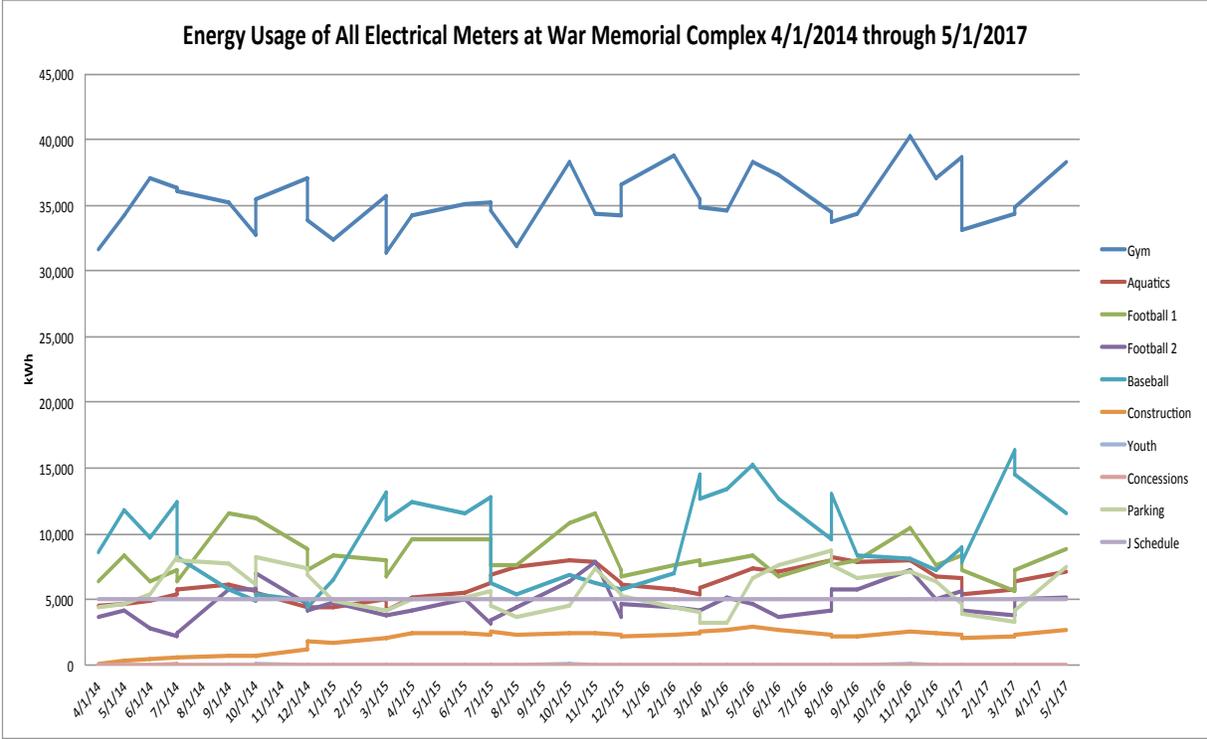
This graph shows the energy use of each meter on the property from April 2014 to May 2017. The purple line at 5,000 kWh shows the minimum usage for a J schedule meter. The gym is Green Building Hawaii

the largest energy consumer on the property, 3.3 times larger than the next largest energy consumer. This increase is due to the pool pumps running all the time, high wattage lighting in the gym that is used daily, and the air conditioning load of the offices that are attached to this building. The usage of this meter is not seasonal and has increased each year.

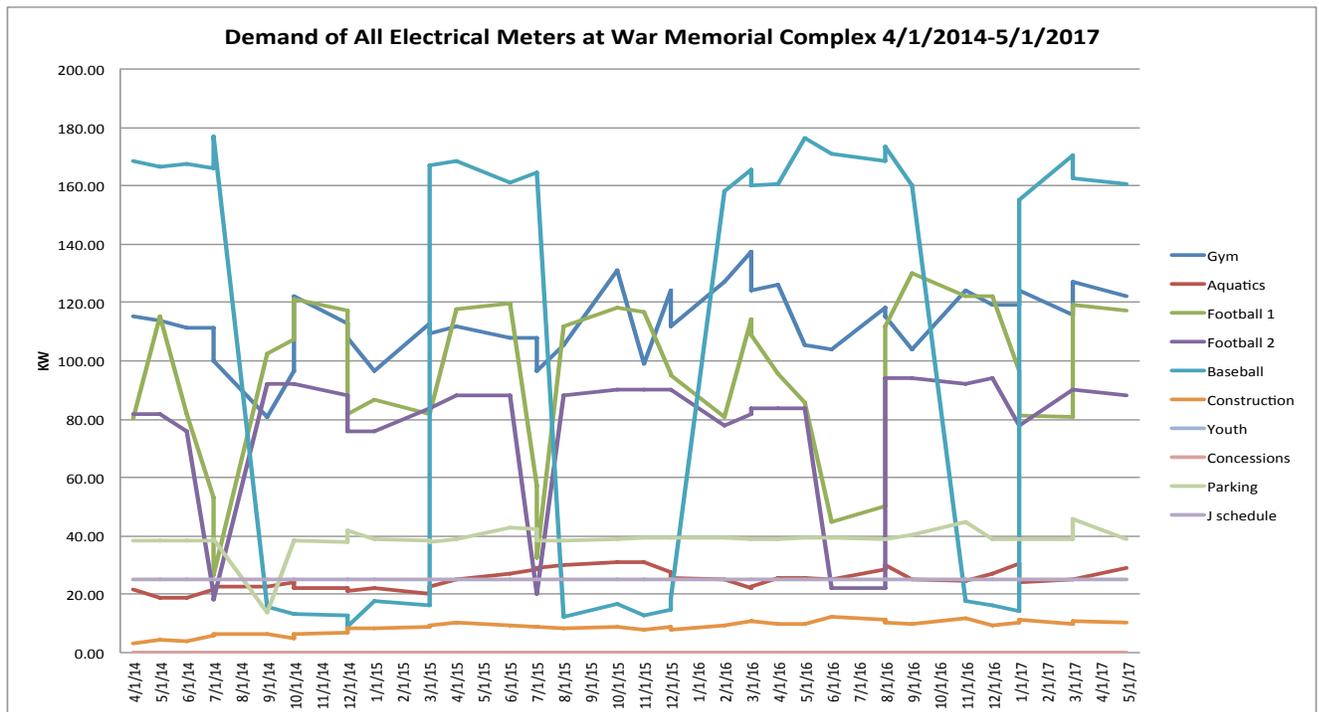
This graph shows the demand of each electric meter on the property from April 2014 to May 2017. The purple line at 25 KW shows the minimum demand for a J schedule meter. This graph shows that the baseball field has the highest demand on the property at 176.6 kW; but combined the two football field meters are significantly higher at around 224 KW. This demand spike is due to the high wattage stadium lighting in these areas. All three of these meters are extremely seasonal with extremely low off season demand.

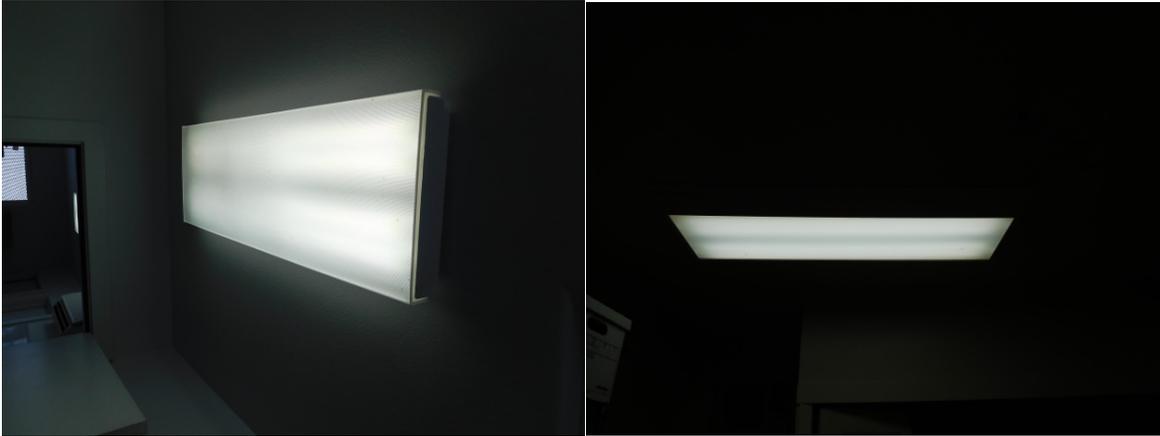
There are 51 existing 4' 4-lamp wraps, 37 existing 2x4 4-lamp T8 troffers and 56 existing 2x4 4-lamp T12 troffers. The 4-lamp T8 fixtures all consume 116-watts per fixture and the T12 fixtures consume 172-watts per fixture.

We are recommending retrofitting all of these with 4 4' LED tubes and a 60-watt driver, which will save approximately 56 & 112-watts respectively.

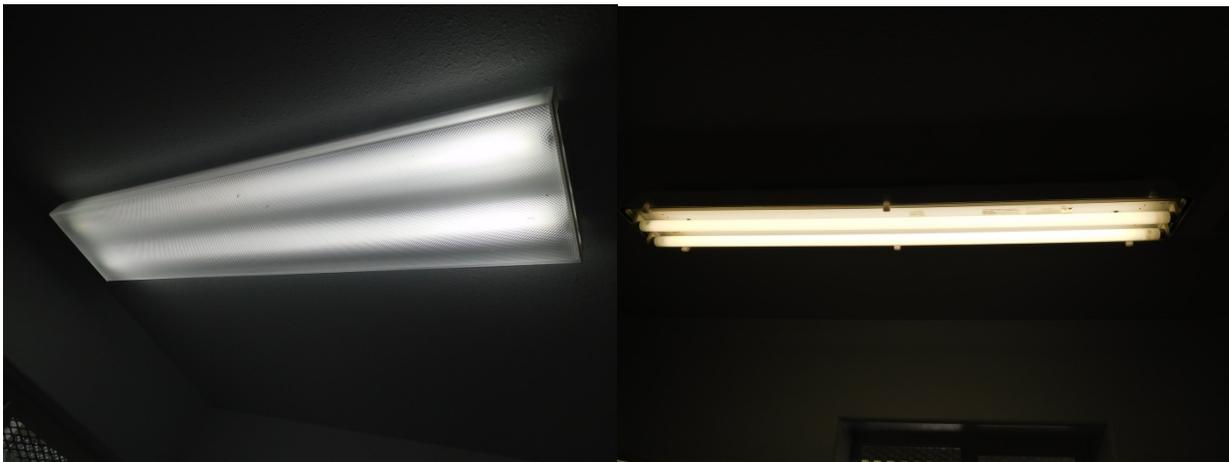
There are 41 existing 4' 2-lamp T8 wraps, 269 existing 4' 2-lamp T8 vaportites, 6 existing 2-lamp T8 strips, all-consuming 58-watts per fixture. There are also 2 existing 4' 2-lamp T12ES strips consuming 72-watts per fixture.

We are recommending retrofitting all of these with 2 4' LED tubes and a 30-watt driver, which will save approximately 28 & 42-watts respectively.

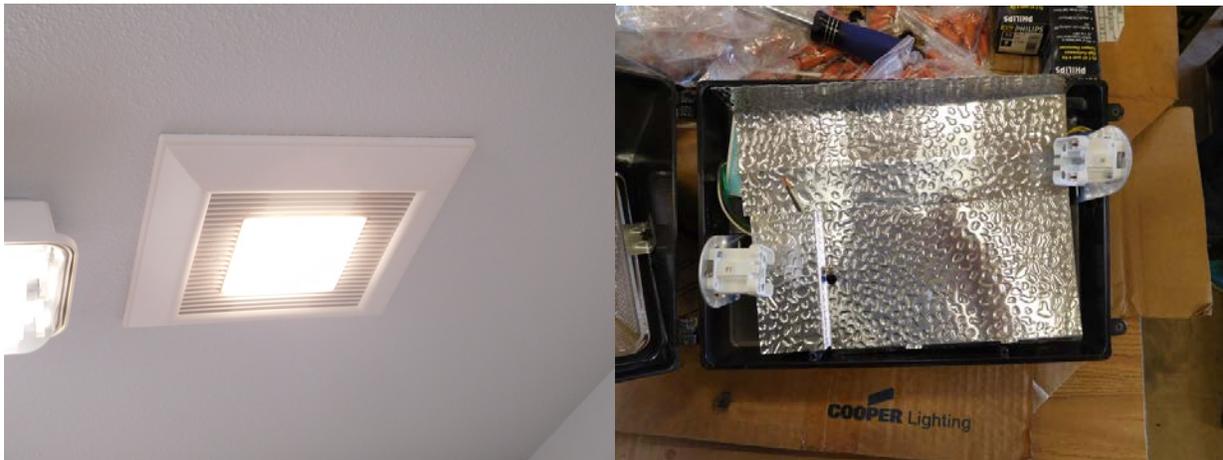
There is 1 existing 32-watt PL Fan Light, 27 existing 2x32-watt PL Recessed Fixtures and 5 existing 2x42-watt PL Wallpacks which consume 32, 64 & 84-watts respectively.

We are recommending retrofitting each lamp with a 12-watt PL LED lamp, which will save 20, 40 & 60-watts per fixture respectively.

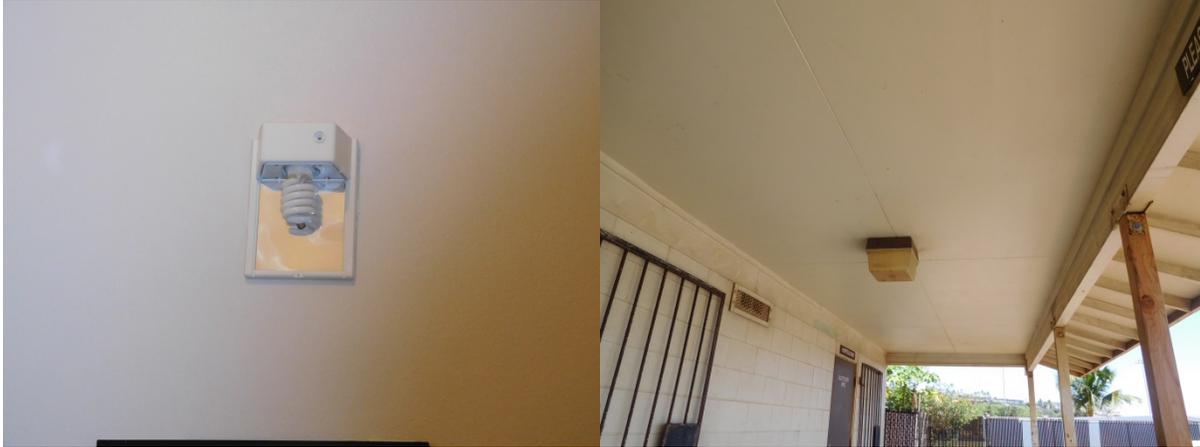
There is 1 existing 32-watt CFL Wallpack, 3 existing 23-watt CFL wallpacks, 6 existing 90-watt incandescent jelly jar and 7 existing 23-watt CFL canopy fixtures consuming 32, 90 & 23-watts respectively.

We are recommending retrofitting these fixtures with a 13-watt LED A21 lamp, which will save 19, 77 & 10-watts respectively.

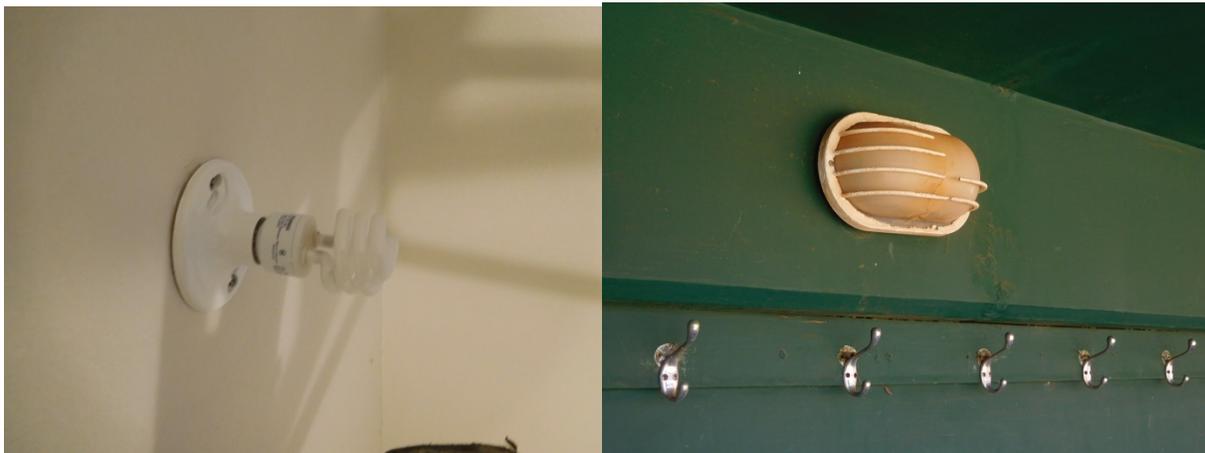
There is 1 existing 19-watt CFL keyless, 2 existing 43A19 bulkheads, 6 existing 23-watt CFL jelly jars and 1 existing 23-watt CFL keyless, which each consume 19, 43 & 23-watts respectively. There are also 6 existing keyless & 4 jelly jar with 13-watt CFL.

We are recommending retrofitting all of these fixtures except the 13-watt with a 10-watt LED A19 lamp which will save 9, 33 & 13-watts respectively. The 13-watt will be replaced with a 7-watt LED A19, which will save 6-watts.

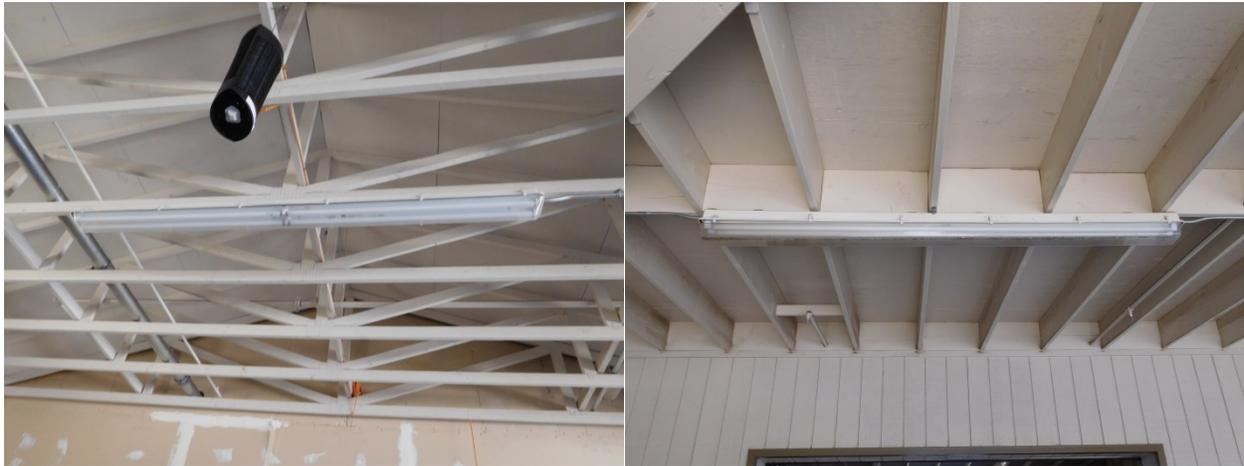
There are 11 existing 8' 2-lamp T8 tandem and 6 existing 8' 2-Lamp T8 (8' lamps) vaportite, which consume 116 & 110-watts respectively. There are also 8 existing 8' T12 and 6 existing 8' 2-lamp T8 strips consuming 155 & 110-watts respectively.

We are recommending retrofitting these fixtures with 2 URS LED bars and a 60-watt driver, which will save 56/50 & 95-watts respectively.

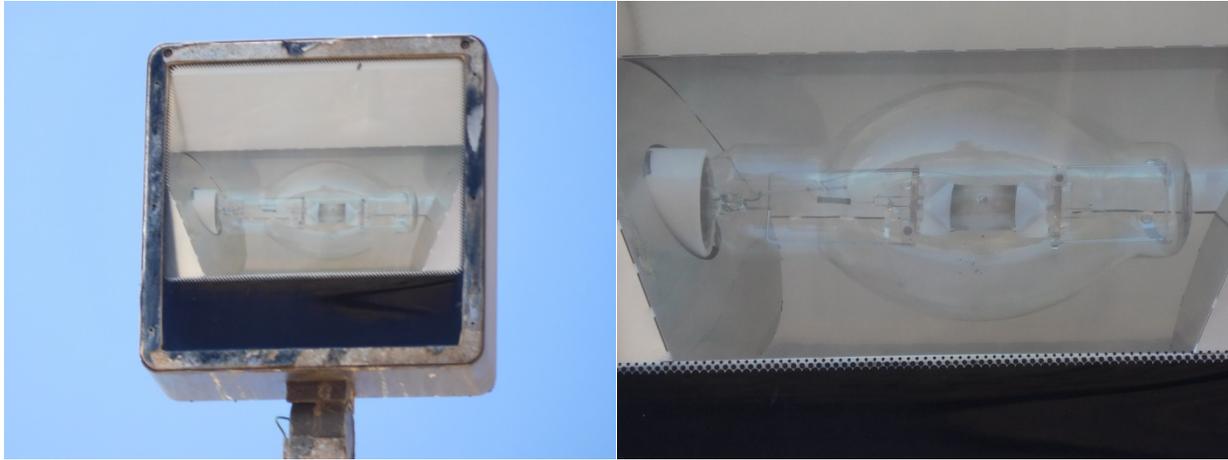
There are 2 existing floodlights and 2 existing horizontal floodlights each consuming 458-watts with the ballast draw.

We are recommending retrofitting the fixtures with a 120-watt LED corn cob lamp which will save about 338-watts per fixture.

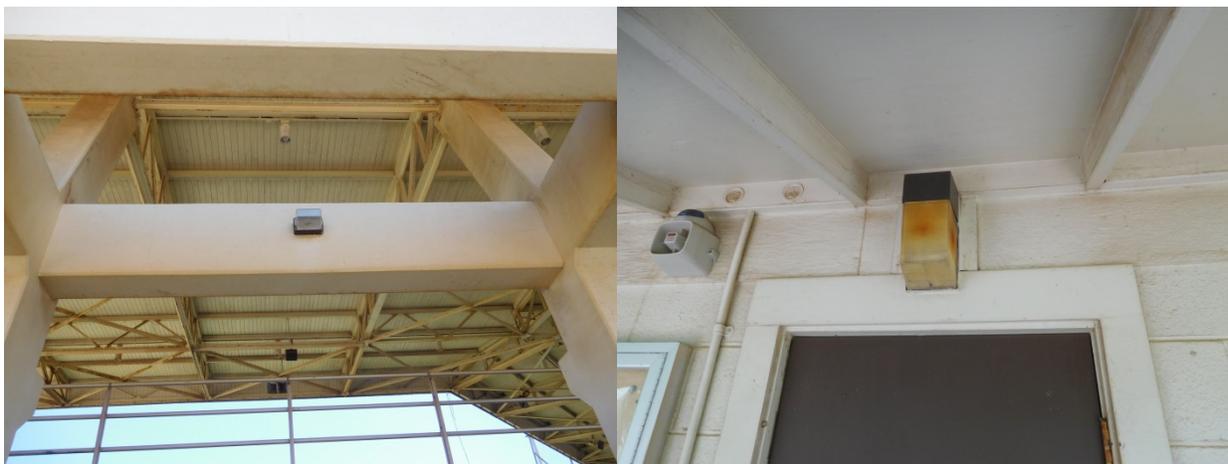
There are 21 existing wallpacks and 9 existing canopy fixtures with 100-watt HPS consuming 125-watts per fixture. There are 14 existing wallpacks and 1 existing canopy fixture with 70-watt HPS consuming 88-watts per fixture. There are 2 horizontal and 4 standard existing floodlights with 150-watt HPS consuming 188-watts per fixture.

We are recommending retrofitting all of these fixtures with a 27-watt LED corn cob lamp which will save about 98/61/161-watts per fixture respectively.

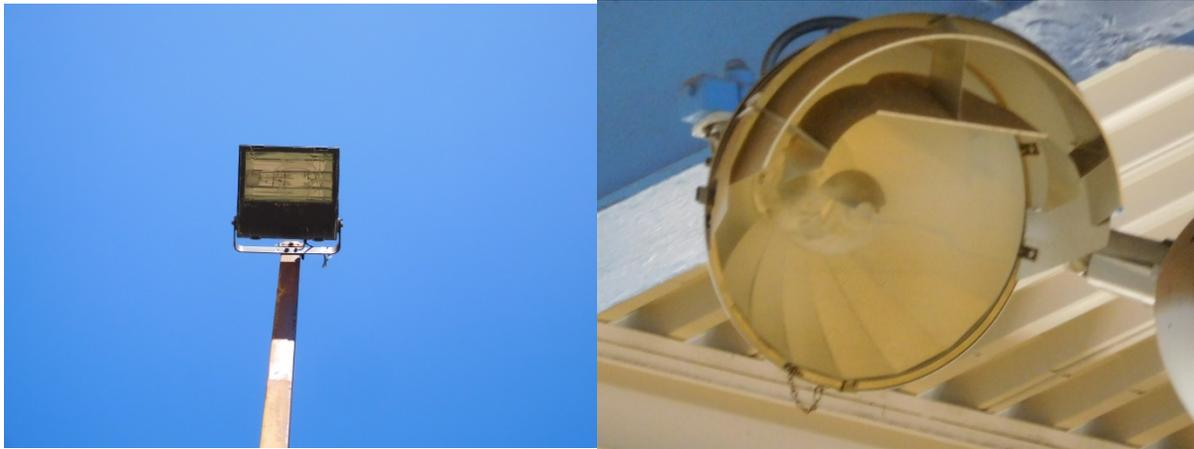
7.1.9 Replace 1000w HID fixtures with LED (summary ECM fixture report 15 & 24)

There are 12 existing 1000-watt floodlights and 46 existing 1000-watt Sportslight fixtures each consuming about 1080-watts including the ballast draw.

We are recommending replacing these fixtures with a 262-watt LED floodlight fixture, which will save about 818-watts per fixture.

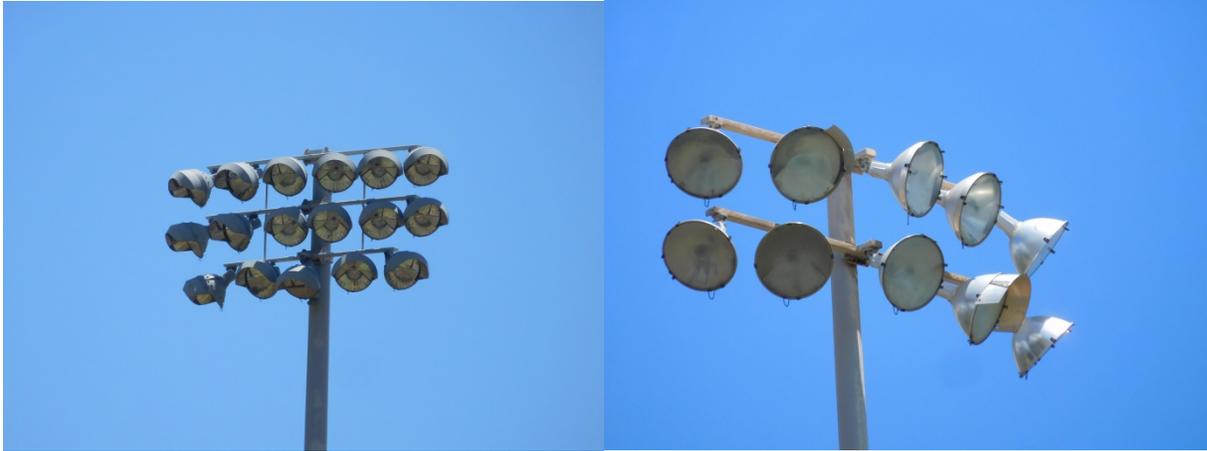
7.1.10 Replace 1500w HID Fixtures with LED (summary ECM fixture report 16 & 62)

There are 188 existing 1500-watt Sportslight fixtures, which consume about 1650-watts per fixture with the ballast draw and the lamps are only rated for 3,000-hours.

We are recommending replacing this entire system with 600-watt LED stadium lighting fixtures with dimming controls, which will save about 1,050-watts per fixture and the lamps are rated at 50,000-hours. In the “Supplemental Documents” folder there are point by point drawings for each field.

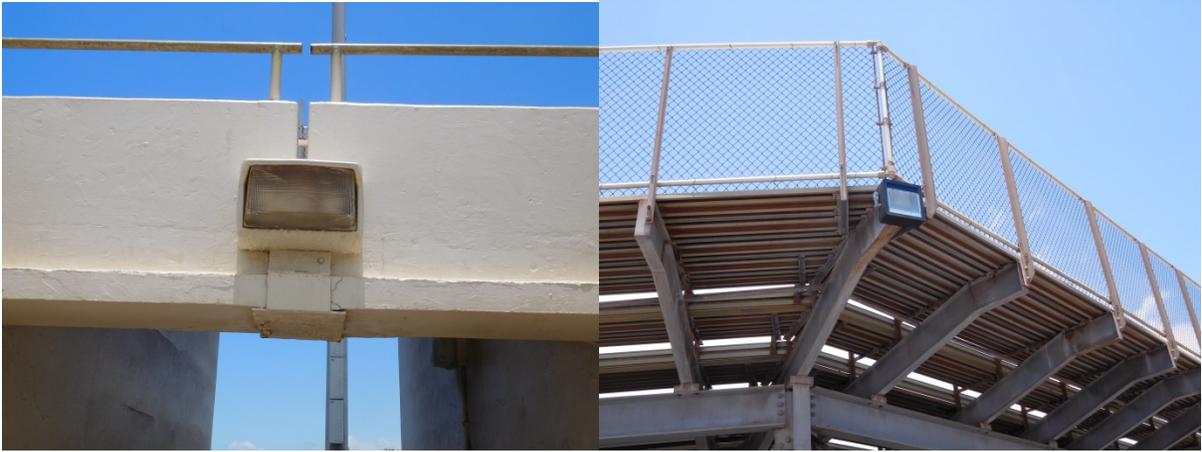
There is 1 existing 250-watt horizontal floodlight, 5 existing 250-watt wallpacks and 2 existing 250-watt floodlights all-consuming about 295-watts with the ballast draw.

We are recommending retrofitting all of the fixtures a 80-watt LED corn cob lamp, which will save about 215-watts per fixture.

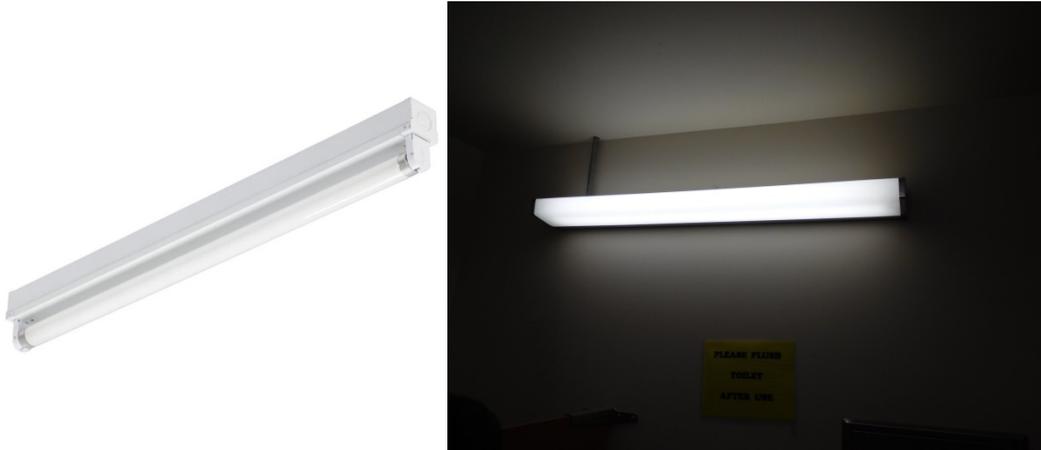
There are 4 existing 4' T12 strips, 1 4' T12ES strip and 15 4' T8 strips as well as 2 4' T12ES wall bracket fixtures all with 1-lamp each. They consume about 50/43/32-watts respectively.

We are recommending retrofitting each fixture with a 4' LED lamp and 18-watt driver, which will save about 32/25/14-watts respectively.

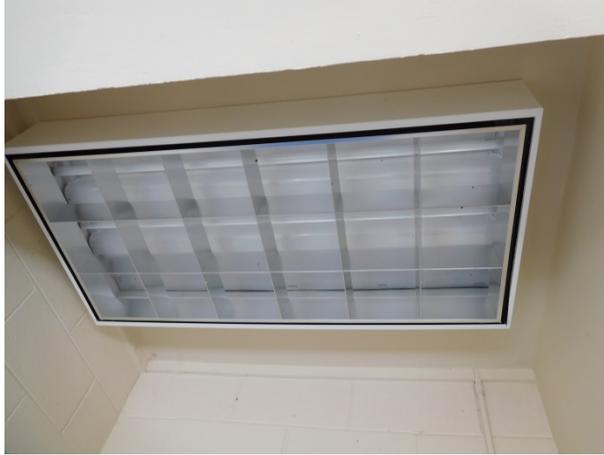
There are 9 existing 2x4 18-cell 3-lamp T8 parabolic fixtures, which consume 90-watts per fixture with the ballast draw.

We are recommending retrofitting each fixture with 3 4' LED lamps and a 44-watt driver, which will save about 46-watts per fixture.

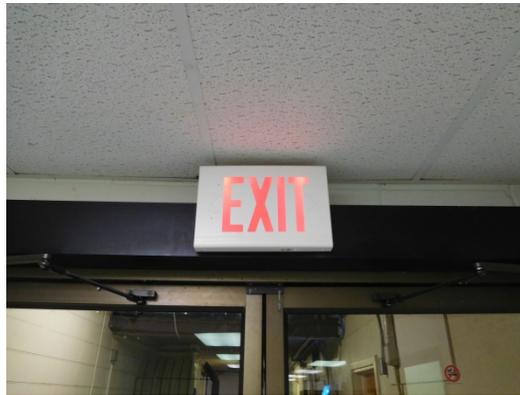
7.1.14 Replace Exit Sign Fixtures with LED (summary ECM fixture report 42)

There are 10 existing incandescent exist signs which consume about 30-watts per fixture.

We are recommending replacing these with a .08-watt LED exit sign, which will save about 29.2-watts per fixture.

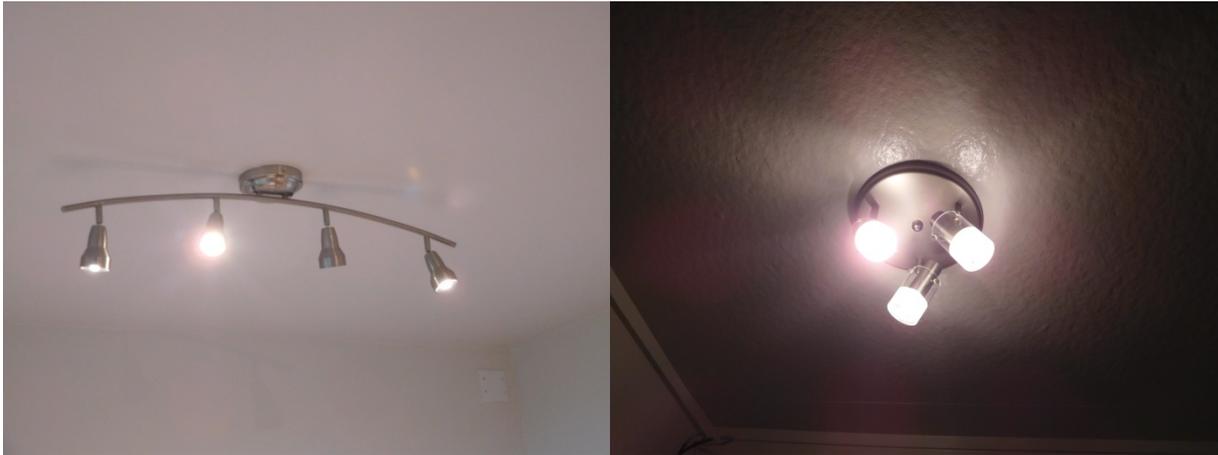
There are 3 existing 3-Lamp and 4 existing 4-lamp 50-watt MR-16 ceiling and track heads each consuming 50-watts per lamp.

We are recommending retrofitting each lamp with a 7-watt LED lamp, which will save about 43-watts per lamp.

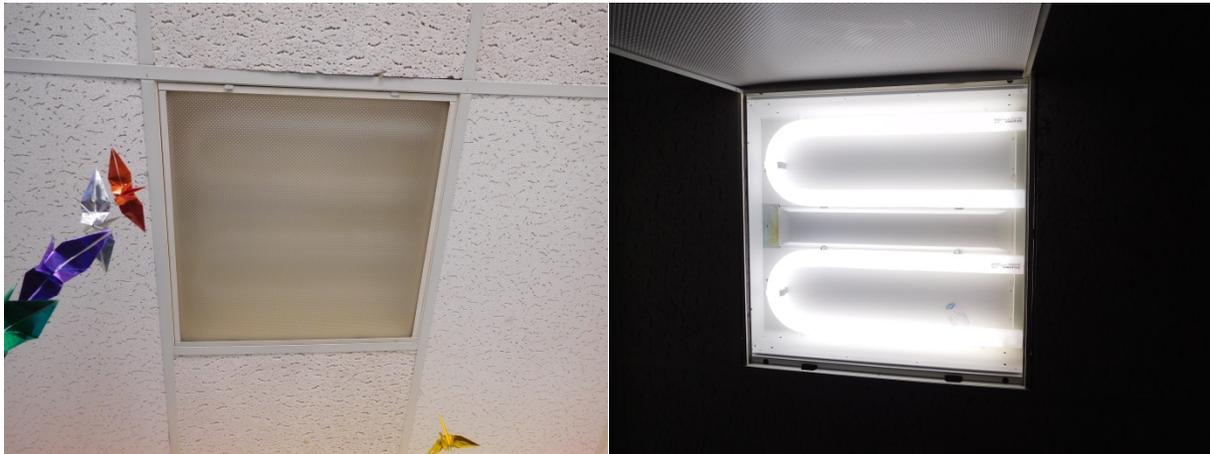
There are 12 existing 2x2 2-lamp T12U troffers, which consume about 86-watts each with the ballast draw.

We are recommending retrofitting each fixture with 2 2' URS LED bars and a 44-watt driver, which will save about 42-watts per fixture.

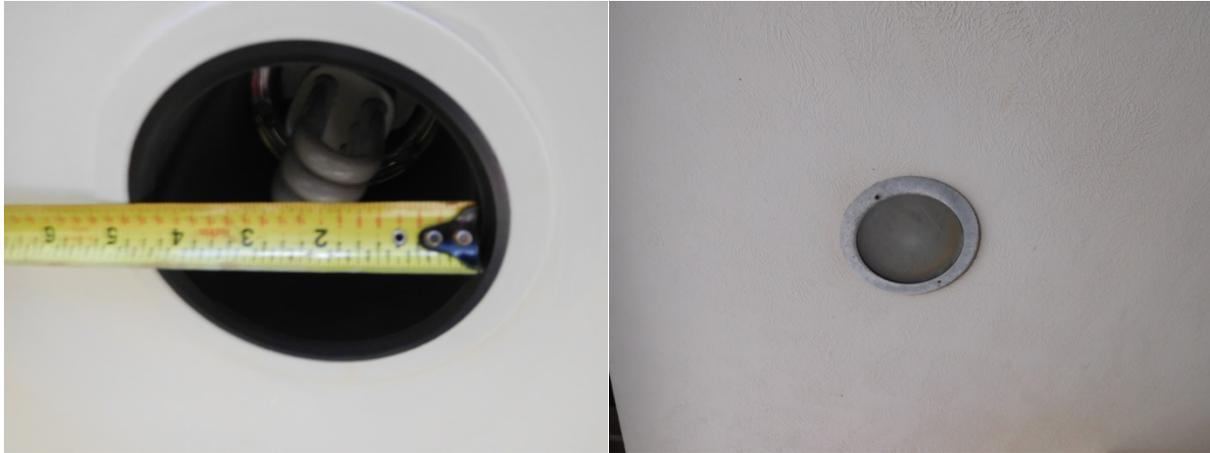
There are 2 existing 4" recessed cans and 1 is 13-watt and 1 is 20-watt CFL. There are also 8 existing 6" recessed cans with 23-watt CFL.

We are recommending replacing the 4” can with a 10-watt LED can and the 6” with a 14-watt can, which will save 3/10/9-watts respectively.

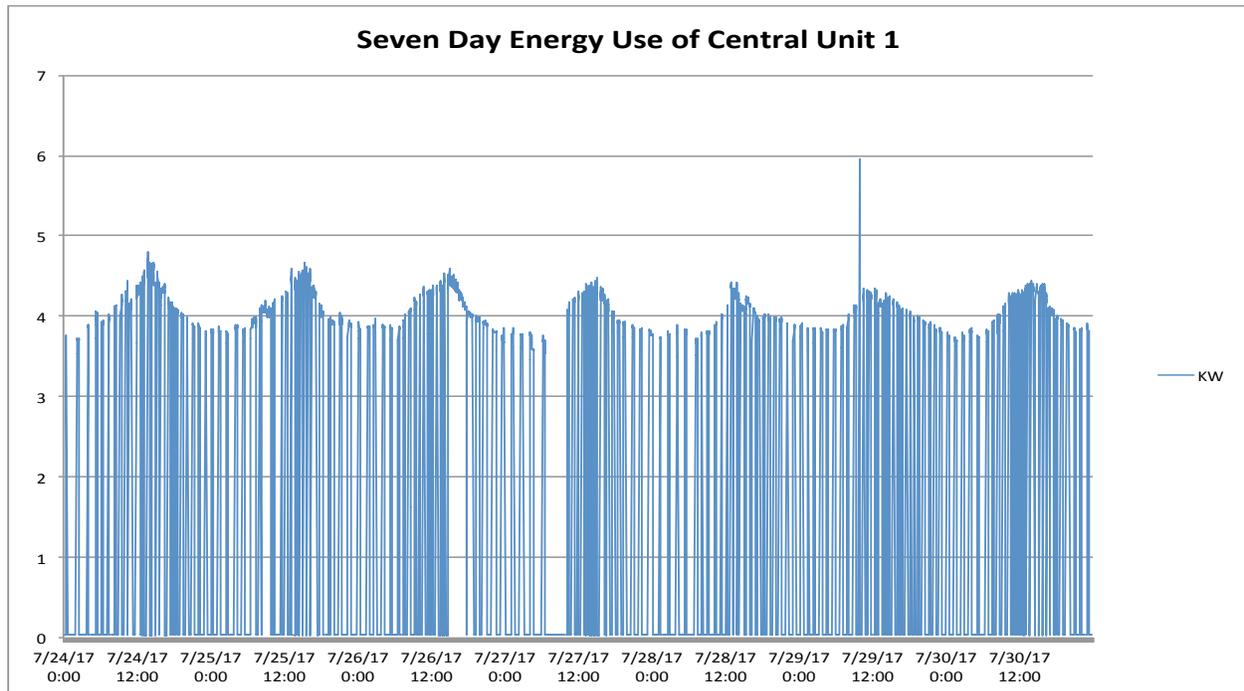
the interior offices of the planning and development offices. This carrier air conditioning system is 3 tons and serves close to 9,550 cubic feet of office space. According to County records it was installed September 19th, 2013, which makes it 4 years old and has not reached its end of life. The audit team was able to monitor the energy use of this unit and it is estimated to use 13,169 kWh or \$3,661 per year. This unit was originally purchased for \$9,927.00.

This graph shows that the central air conditioning system uses around 4 KW of electricity when running. This unit ramps on and off all the time, which is a sign that the digital thermostat is not properly programmed to turn off or increase the temperature setting during the nights and weekends. This energy conservation measure can reduce the energy use significantly and is a no cost measure. For the size and run time of this unit it is operating at an average efficiency and is not recommended to be replaced.

- Set digital thermostat to turn off or increase temperature settings for nights and weekends
- Hire an air conditioning contractor to service the unit and start a maintenance contract for continual service
- Once the unit has reached its end of life replace with an Energy Star certified model
- Apply for Hawaii Energy rebates

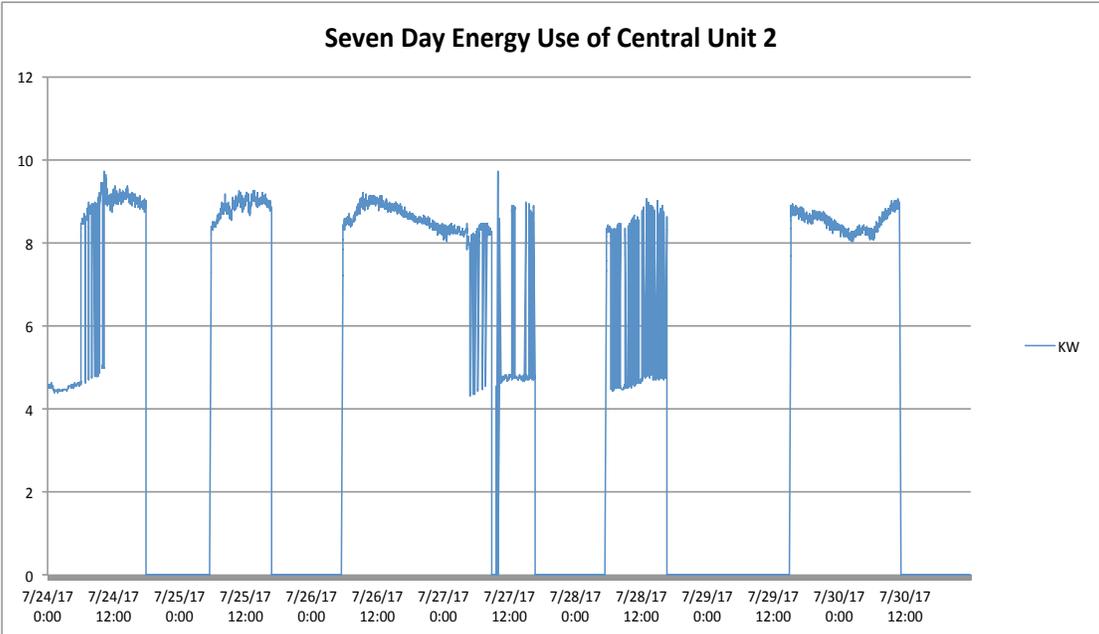
Central unit #2 condensing unit is located on the roof of the aquatics and permitting office and the air handler is located in the ceiling of the offices. This unit serves half of the cubic footage of the aquatics and permitting office and central unit 3 serves the other half. This carrier air conditioning system is 10 tons and serves close to 20,924 cubic feet of office space. According to County records it was installed October 27th, 2007 making it 10 years old and has reached its end of life. The audit team was able to monitor the energy use of this unit and it is estimated to use 37,927 kWh or \$11,378 per year. Visual inspection identified a significant amount of rust, the air filter had not been changed for a long time and was in serious need of maintenance. This unit was originally purchased for \$11,933.50.

This graph shows that the central air conditioning system uses around 9 KW of electricity when running. This unit turns on in the morning when people come to work around 5:30 AM and runs constantly through out the day. It also ran through out the night twice during this seven day period which shows that this is probably on a manual thermostat and is not programmable. The nights that the system ran all night is a sign that the employees did not turn the system off when they left work. For the size and run time of this unit it is not operating at an acceptable efficiency and is recommended to be replaced.

- This unit has reached end of life and needs to be replaced
- When replacing this unit it is recommended to have a third party load calculation done to ensure proper sizing of equipment

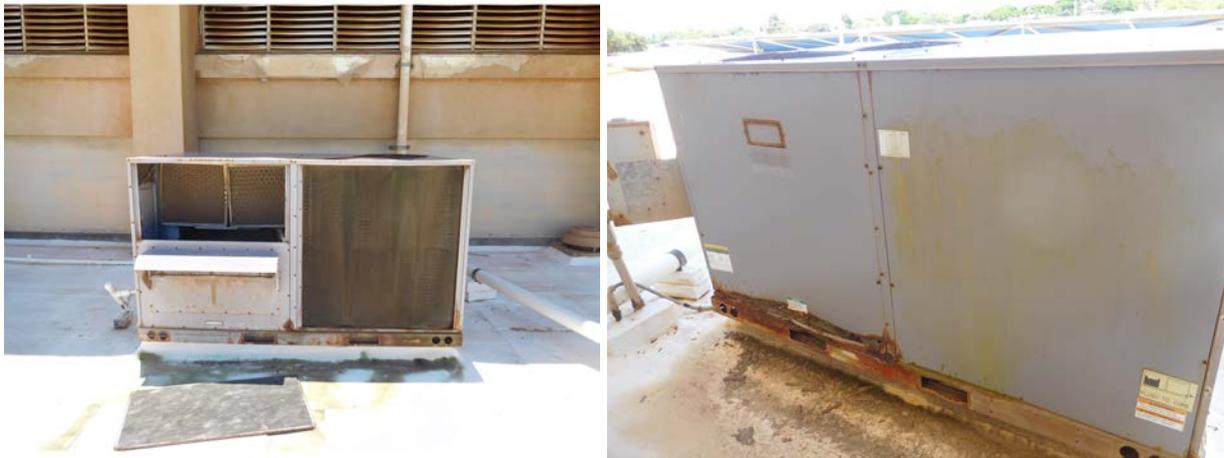
Central unit #3 condensing unit is located on the roof of the aquatics and permitting office and the air handler is located in the ceiling of the offices. This unit serves half of the cubic footage of the aquatics and permitting office and central unit 2 serves the other half. This carrier air conditioning system is 10 tons and serves close to 20,920 cubic feet of office space. According to County records it was installed October 27th, 2007 making it 10 years old and has reached its end of life. The audit team was not able to monitor the energy use of this unit but it is the exact same size, model and age of central unit #2 and it serves almost the exact same amount of cubic feet, we estimated usage at the same 37,927 kWh or \$11,378 per year. Since this unit was not monitored the run time and efficiency may be slightly different than central unit 2 but it can be inferred that they are very similar. Visual inspection significant amounts of rust, the air filter had not been changed for a long time and was in serious need of maintenance. This unit was originally purchased for \$11,933.50

The following pictures show the condition of the unit.

- This unit has reached end of life and needs to be replaced
- When replacing this unit it is recommended to have a third party load calculation done to ensure proper sizing of equipment
- When replacing this unit make sure to purchase Energy Star certified equipment
- Apply for Hawaii Energy rebates

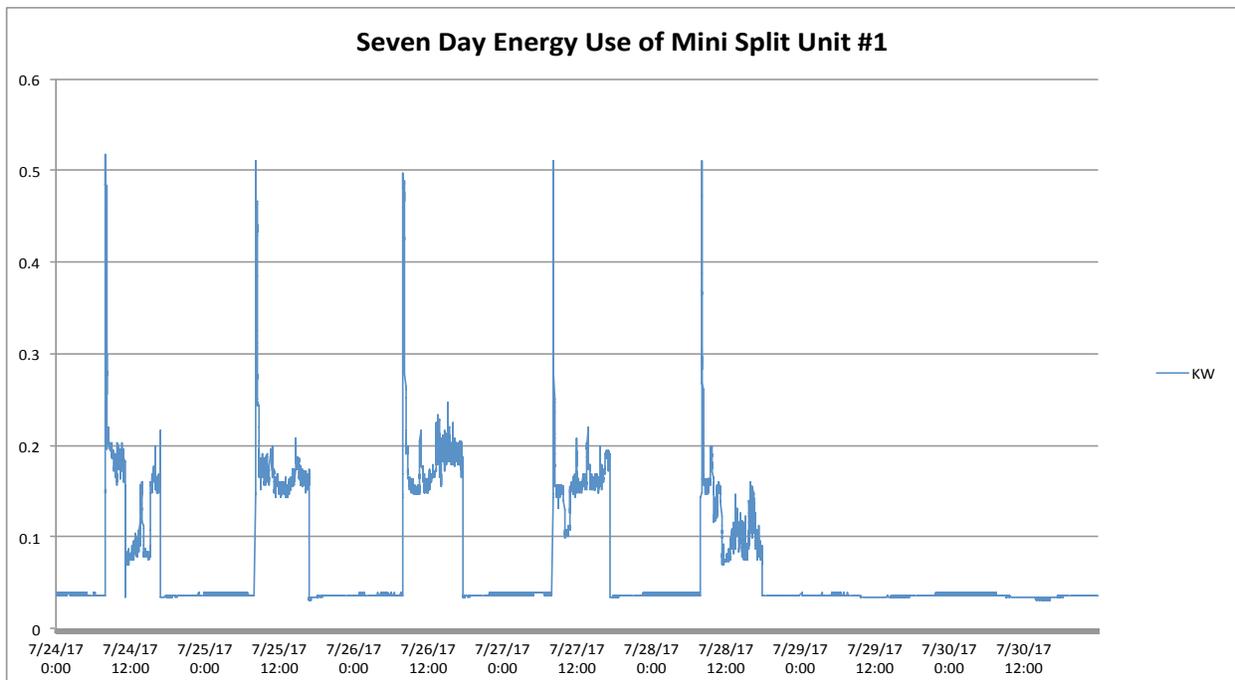
This graph shows that the mini-split unit #1 uses around .2 KW of electricity when running with a start up spike around .5 KW. This unit turns on in the morning when people come to work around 8:00 AM and runs constantly through out the day. It does not turn off but it does ramp down through out the day, which means that it is properly sized for the space.

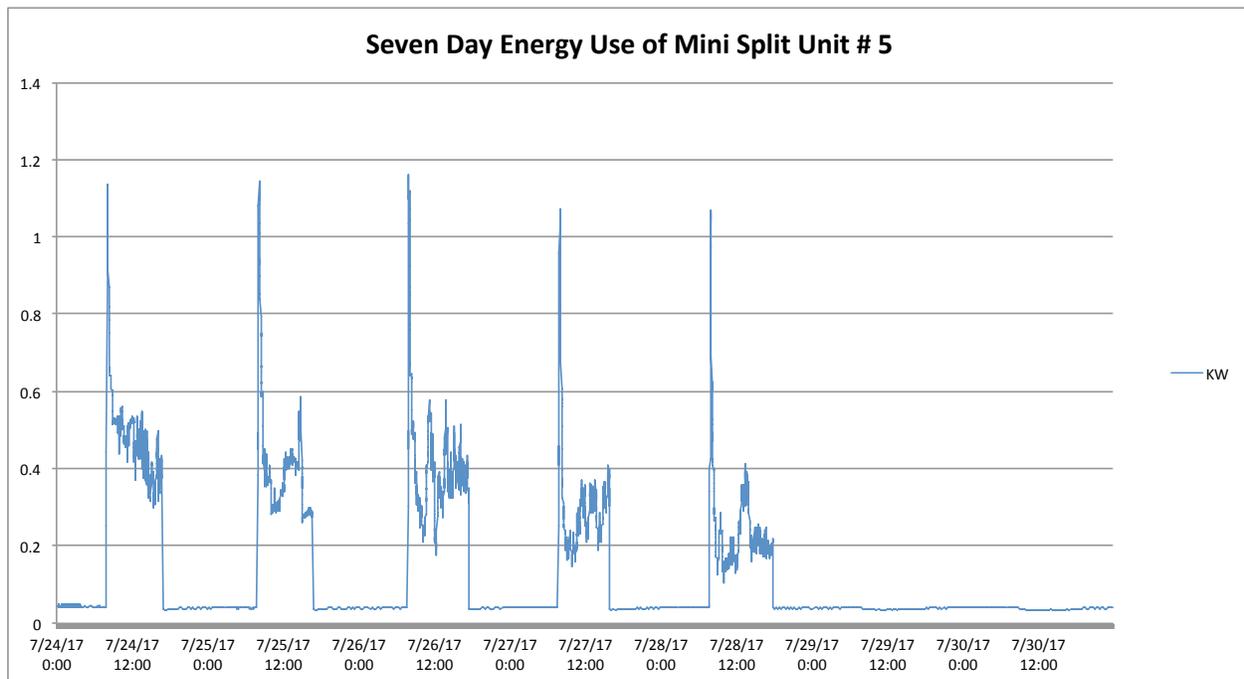
This graph shows that the mini-split unit #5 uses around .5 KW of electricity when running with a start up spike just above 1 KW. This unit turns on in the morning when people come to work around 8:00 AM and runs constantly through out the day. It does not turn off or ramp down through out the day, which means that it never hits set point and may be slightly under sized or the temperature settings are too low.

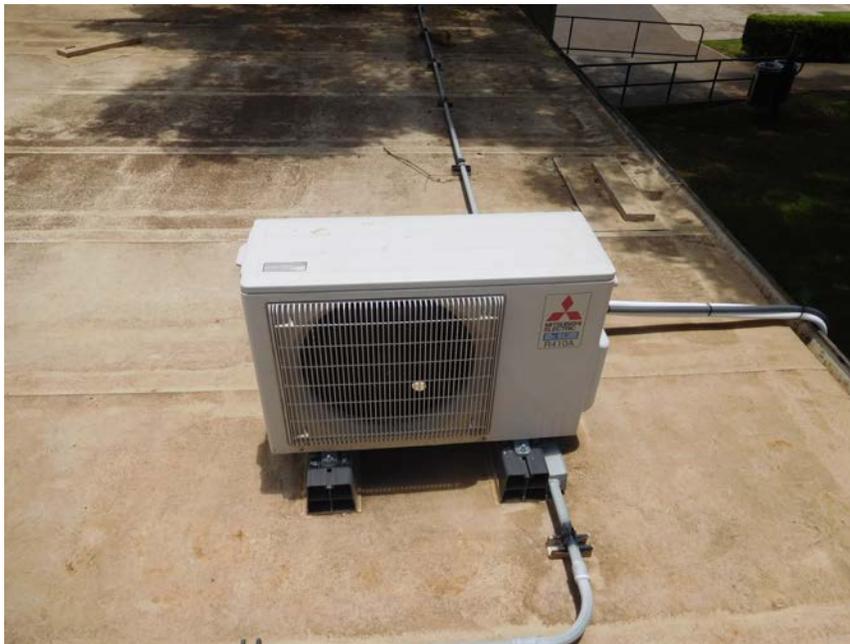
Mini split unit 4 condensing unit is located on the roof of the parks and recreation office and the air handler is located in office 2 of the parks and recreation offices. This Mitsubishi air conditioning system is 1 ton and serves close to 1,320 cubic feet. County records do not have any information on the installation date of this unit but it looks to be the same generation as units 1, 2, 3, and 5 and it has not reached its end of life. The audit team was not able to monitor the energy use of this unit but based on a visual inspection this unit is still in good condition and is of average efficiency and it is not recommended to replace it. It is recommended to hire a contractor to service the units and get on a regular maintenance contract. There is no record of how much was paid for this unit.

The following picture shows the condition of the unit.

- It is recommended to hire a contractor to service the units and get on a regular maintenance contract.
- Once the unit has reached its end of life replace with an Energy Star certified model
- Apply for Hawaii Energy rebates

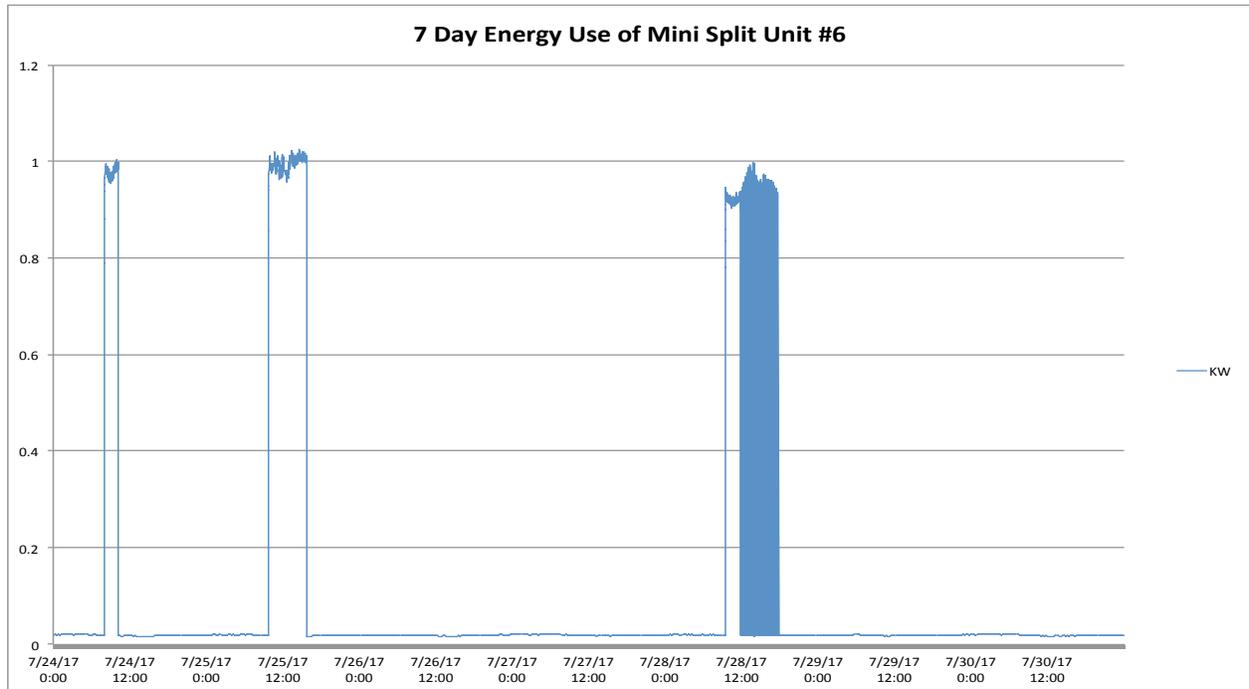
This graph shows that this mini split air conditioning system uses around 1 KW of electricity when running. This unit is only used when there are meetings in progress in the conference room. The week it was monitored it was only used three times for a total of 15 hours. For the size and run time of this unit it is operating inefficiently but because of these limited run times the financial benefit of replacing this unit before it breaks down would not make sense.

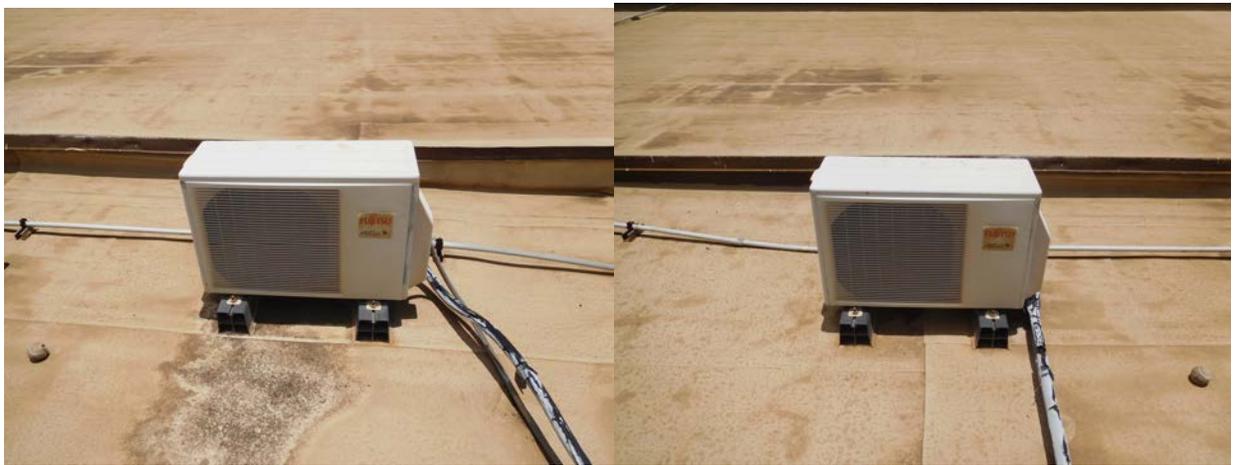
This infrared image shows that the coils are heated evenly and the system is operating correctly

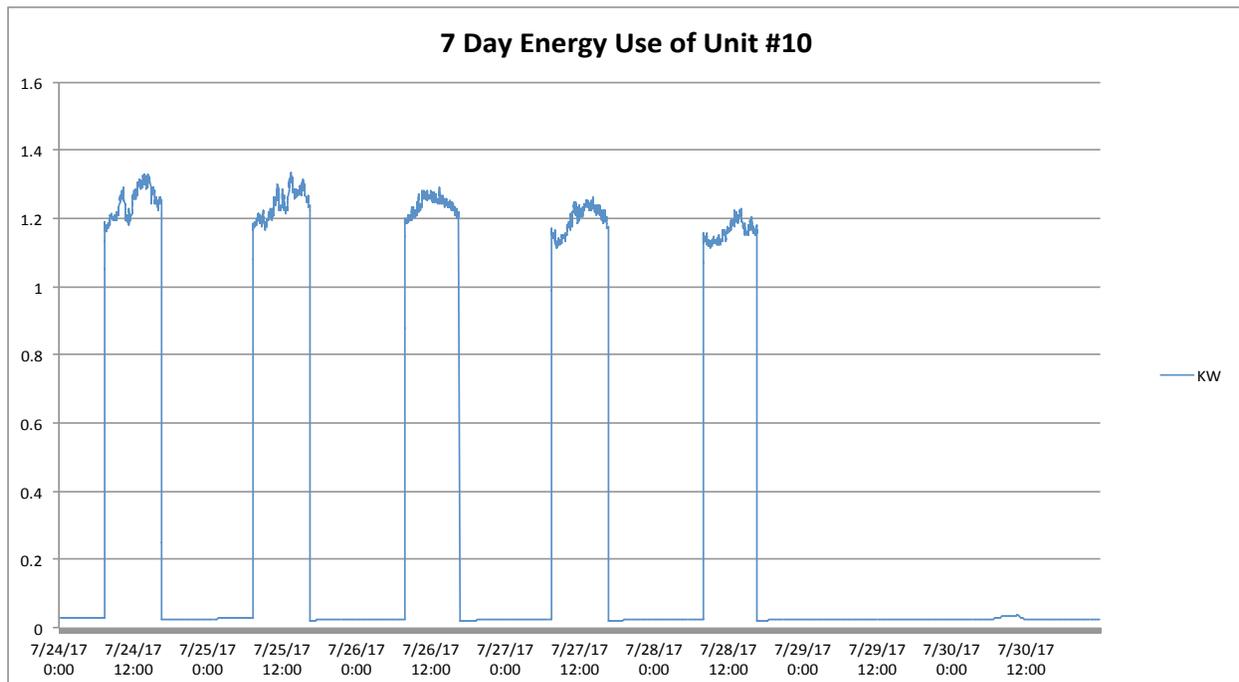
This graph shows that the mini-split unit #10 uses around 1.2 KW of electricity when running. This unit turns on in the morning when people come to work around 8:00 AM and runs constantly through out the day until 4:30 when the employee leaves the office. It does not turn off or ramp

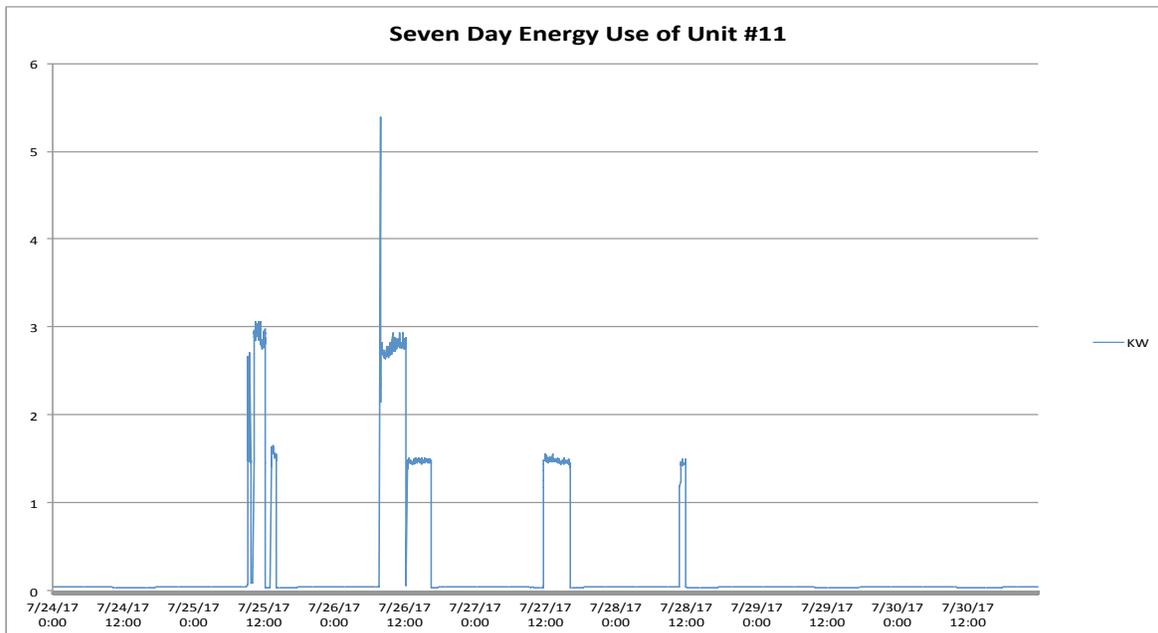
This graph shows that this mini split air conditioning system uses around 3 KW of electricity when running both zones or 1.5 KW when it is only running one zone. This unit is only used when there are meetings in progress in the conference room. The week it was monitored it was only used four times for a total of 11 hours. For the size and run time of this unit it is operating inefficiently but because of these limited run times the financial benefit of replacing this unit before it breaks down would not make sense. There is no record of how much was paid for this unit.

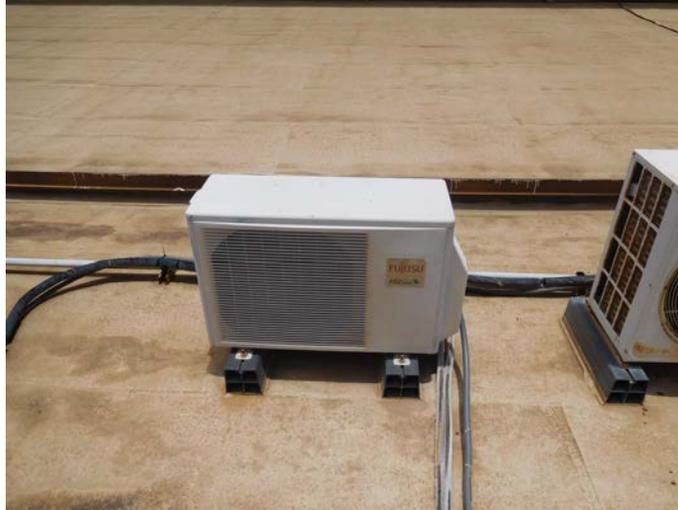
This unit is no longer functioning and has reached its end of life. County records show that this unit was installed April 7th 2008, which makes this unit 9 years old. During visual inspection we did not identify any issues with this unit but due to its age and the fact it is not working we recommend replacing as soon as possible.

The following picture shows the condition of the unit.

- Replace this unit
