ENERGY ASSESSMENT AUDIT REPORT

WAR MEMORIAL COMPLEX

700 HALIA NAKOA STREET

WAILUKU, HI 96793

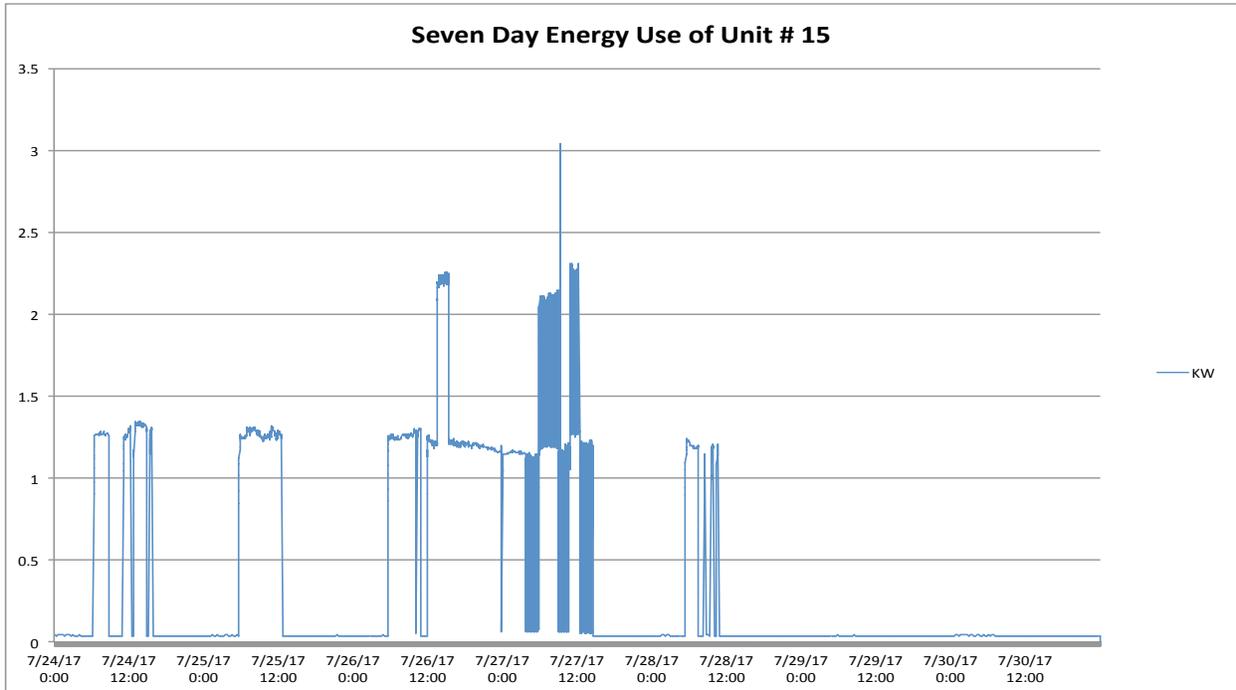
This graph shows that this mini split dual zone air conditioning system uses around 2.5 KW of electricity when running both zones or 1.25 KW when it is only running one zone. This unit is normally turned on when the employee gets to work and turned off when the employee leaves. It appears that these offices rarely run the unit at the same time. These units are running inefficiently and are near end of life, it is recommended to replace them.

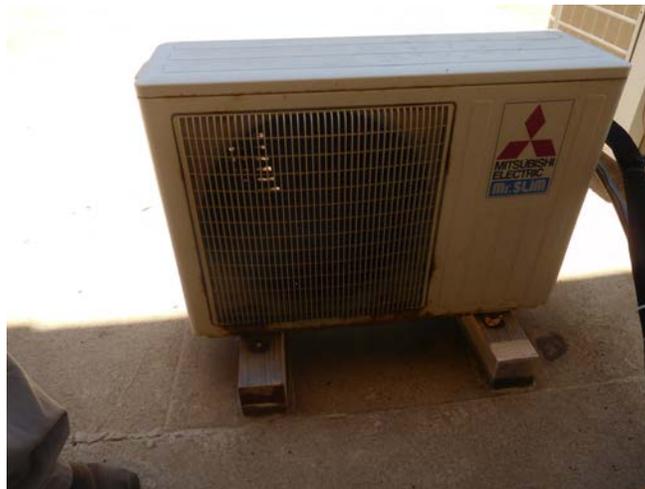
Mini split unit 17 condensing unit is located on the roof of the planning and development offices and the air handler is located in the office 19. This Mitsubishi air conditioning system is 1 ton and serves close to 1,064 cubic feet. County records show this unit was installed January 9th 2006, which makes it 11 years old and is near reaching end of life. Upon visual inspection this unit has started to rust and needs maintenance. The audit team was not able to monitor the energy use of this unit due to accessibility. The units look like they are in average condition and we recommend monitoring the energy use of it before replacing it. It is recommended to hire a contractor to service the unit and get on a regular maintenance contract to get the most life from the unit before it breaks. This unit was originally purchased for \$5,168.

The following pictures show the condition of the unit:

- Monitor energy use of this unit for accurate energy use profiles before replacing
- It is recommended to hire a contractor to service the units and get on a regular maintenance contract.
- Once the unit has reached its end of life replace with an Energy Star certified model
- Apply for Hawaii Energy rebates

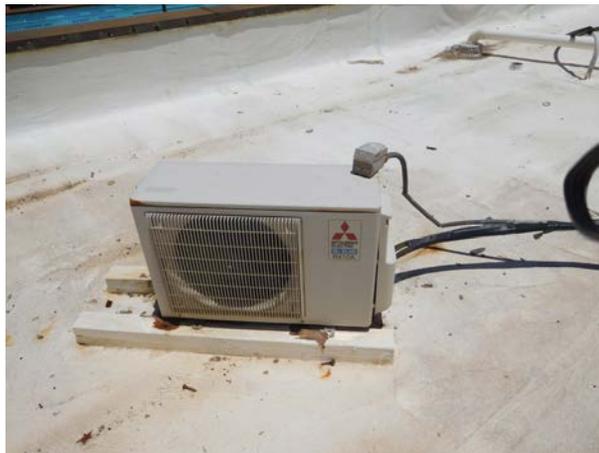
Mini split unit 18 condensing unit is located on the roof of the permitting offices and the air handler is located in the server room. This Mitsubishi air conditioning system is 1 ton and serves close to 720 cubic feet with a constant heat load from the servers. County records show this unit was installed April 12th 2012, which makes it 5 years old and has not reached its end of life. Upon visual inspection this unit is still in good condition. The audit team was not able to monitor the energy use of this unit due to accessibility. It is recommended to hire a contractor to service the unit and get on a regular maintenance contract to ensure the best efficiency and get the most life from the unit before it breaks. This unit was originally purchased for \$3,147.

The following pictures show the condition of the unit:

- Monitor energy use of these units for accurate energy use profiles before replacing
- It is recommended to hire a contractor to service the units and get on a regular maintenance contract.
- Once the unit has reached its end of life replace with an Energy Star certified model
- Apply for Hawaii Energy rebates

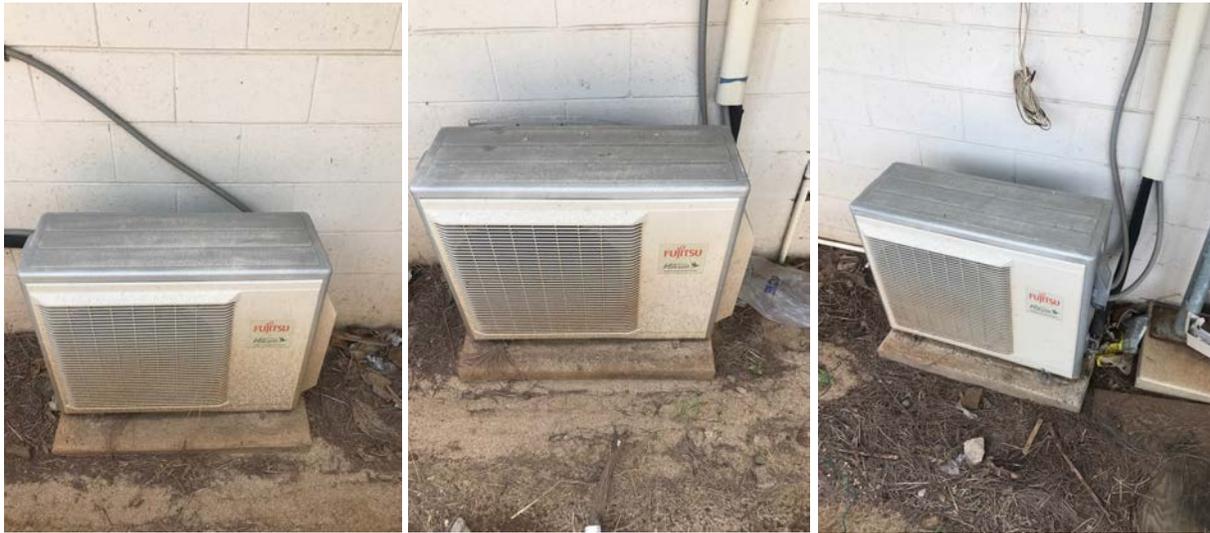
The following pictures show the condition of the units:

- It is recommended to hire a contractor to service the units and get on a regular maintenance contract.
- Once the unit has reached its end of life replace with an Energy Star certified model
- Apply for Hawaii Energy rebates

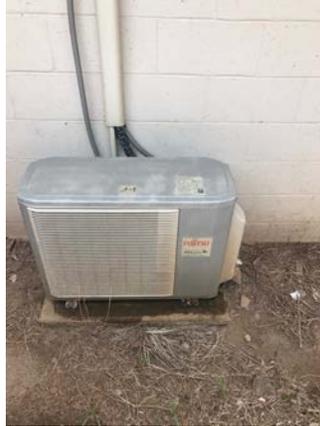
Mini split unit 22 condensing unit is located behind the construction and maintenance office and the air handler is located in the break room. This Mitsubishi air conditioning system is 2 ton and serves close to 8,000 cubic. County records show this unit was installed August 22nd 2011, which makes it 6 years old and has not reached its end of life. Upon visual inspection this unit is still in good condition. The audit team was not able to monitor the energy use of this unit due to accessibility. There are no other units of this size on the property to compare this unit to. It is recommended to hire a contractor to service the unit and get on a regular maintenance contract to ensure the best efficiency and get the most life from the unit before it breaks. This unit was originally purchased for \$4,999.97

The following picture shows the condition of the unit:

- It is recommended to hire a contractor to service the units and get on a regular maintenance contract.
- Once the unit has reached its end of life replace with an Energy Star certified model
- Apply for Hawaii Energy rebates

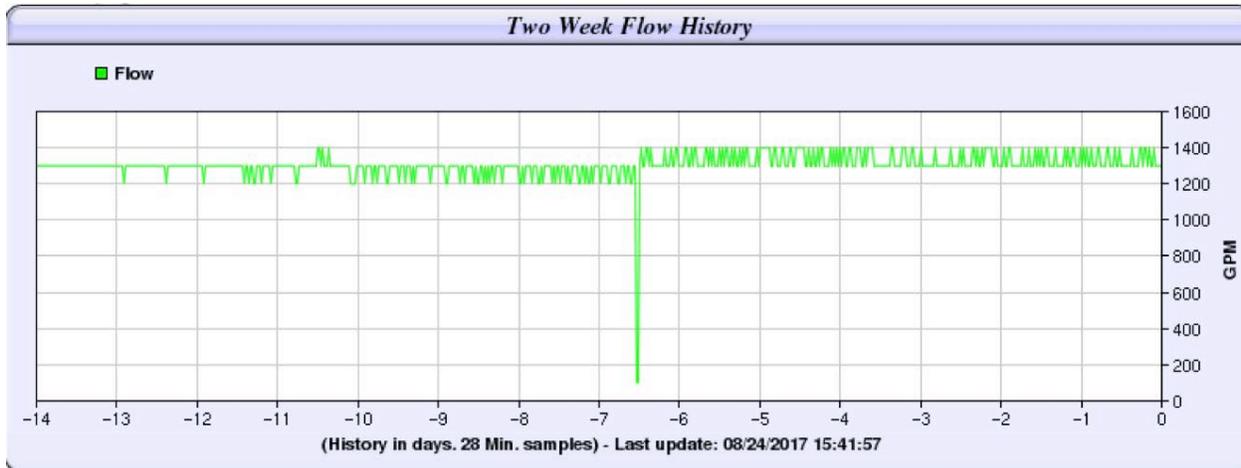
This chart shows the flow rate of the pool before a back flush of the filters around 1,200-1,300 gallons per minute. Halfway through the monitoring period the pool is turned off and a change was made that increased the flow rate to 1,300-1,400 gallons per minute. This allows us to calculate the recirculation rate of 4.2-4.9 cycles per day and may allow the pool employees to reduce the amount of energy used in filtering the pool water by reducing the flow rate.

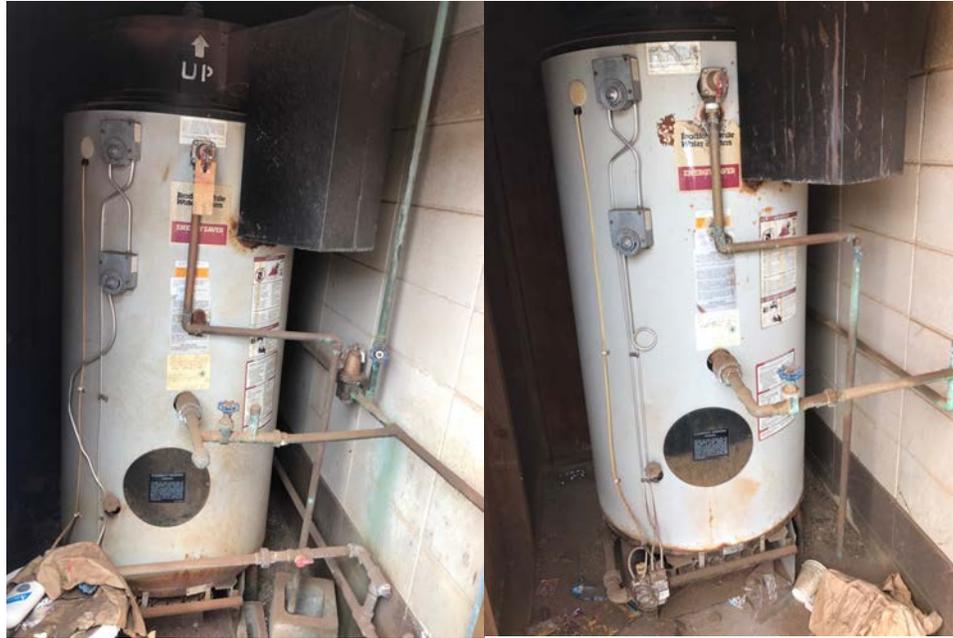
Since the pool pump is turned off during summer months, the propane usage of these units was calculated by finding the propane usage during the summer, which was 200 gallons over three months, dividing that by three to find the total monthly usage, then dividing by three to find the usage per unit and then multiplying that by twelve. It is estimated that the annual usage for each water heater is 266.67 gallons of propane or \$705.67 per year. It is likely that the units providing water to the pool locker rooms use more propane than the newer unit that provides water to the gym locker rooms.

The following pictures show the condition of the units:

- Perform an engineering study to provide more information on cogeneration or solar water heating opportunities
- Maintain the existing equipment to ensure highest efficiency and extended life of equipment
- Insulate all hot water pipes

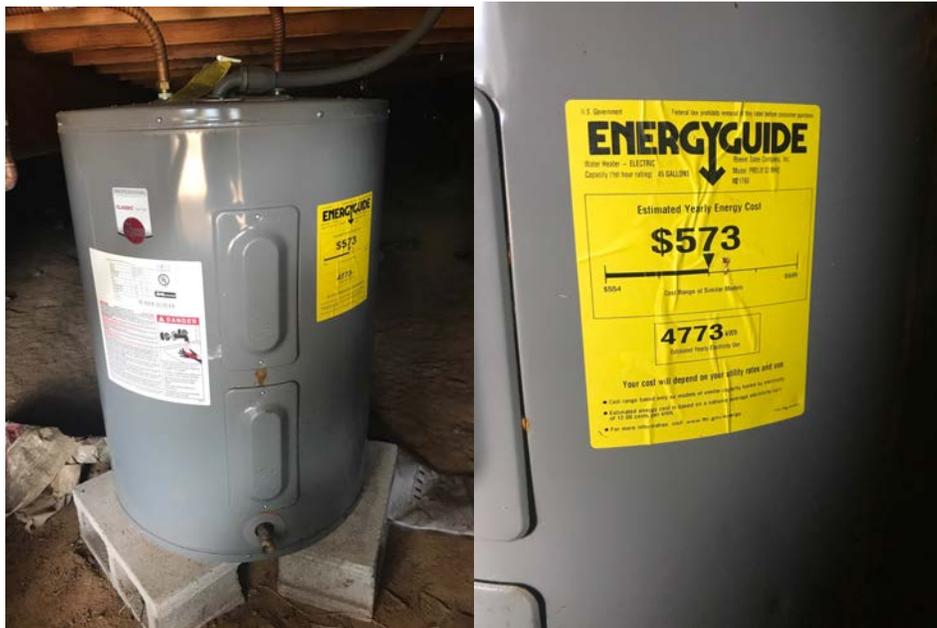
This water heater is a residential size 45 gallon water heater and looks to be new and in good condition. The energy use of this unit was not monitored due to accessibility but during the inspection it was noted that there was no time clock on the unit. Without a time clock this unit will heat water through out the night and weekends wasting unneeded energy. The energyguide label on the tank estimates an energy use of 4773 kWh and based on the most recent blended utility rate for this utility meter of \$.30, the annual cost would be \$1,431. This unit is rated as an average efficiency. It is recommended that a time clock be installed on this unit and a more in depth study be done on the energy use of this unit to compare it to a higher efficiency system such as solar hot water or a residential heat pump system.

The following pictures show the condition of the unit and the energyguide label:

- Do an engineering study to provide more information on cogeneration, heat pump or solar water heating opportunities
- Monitor energy use to get a more accurate assessment of energy usage
- Maintain the existing equipment to ensure highest efficiency and extended life of equipment

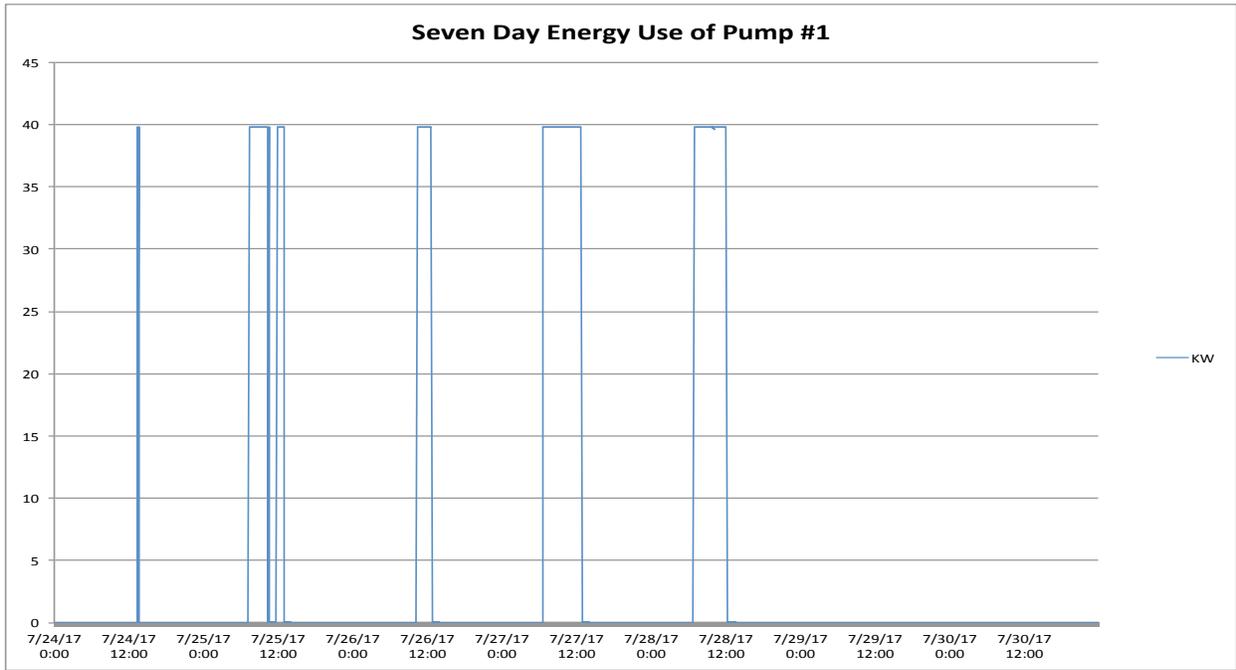
This graph shows the operating hours of the pump. This pump has a single speed motor so the unit is either 100% on or off.

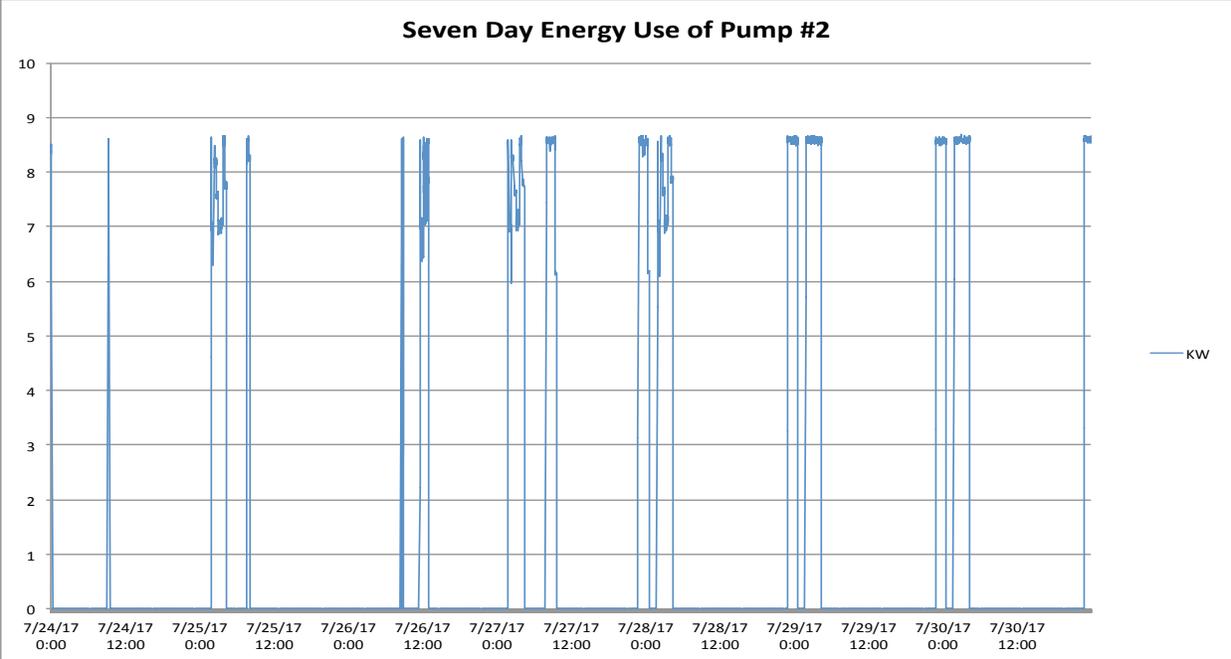
This graph shows the operating hours of this pump. This pump has a variable speed drive motor which allows the pump to change the speed of the pumping but the majority of the time the motor is 100% on.
